MISCELLANEOUS PAPER GL-89-5

STUDY OF EMBANKMENT PERFORMANCE DURING OVERTOPPING AND THROUGHFLOW

Report 1 FEASIBILITY STUDY

Hon-Yim Ko, R. Jeffrey Dunn, Ebrahim Simantob

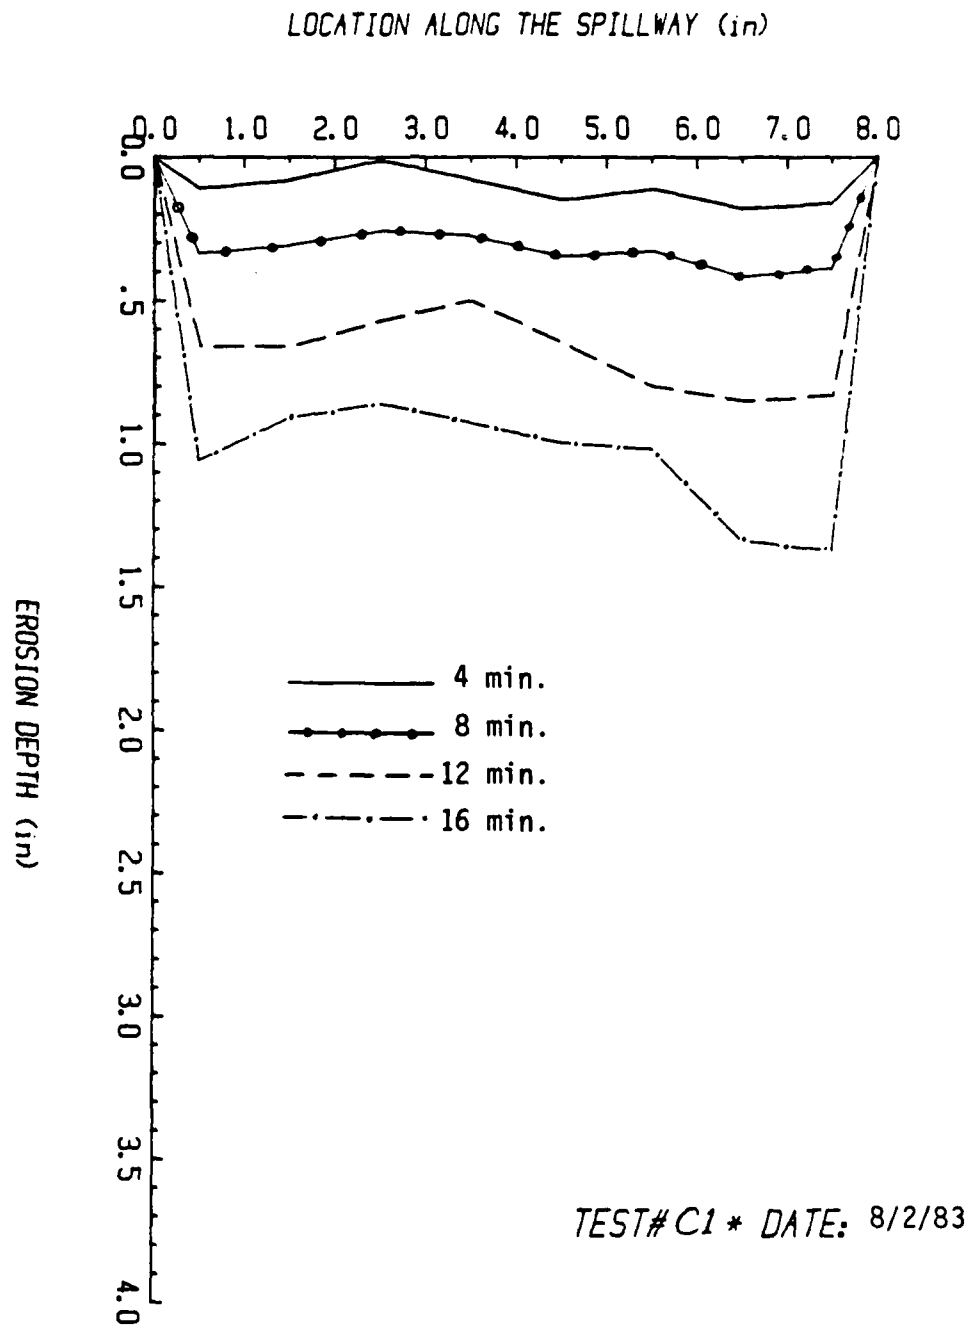
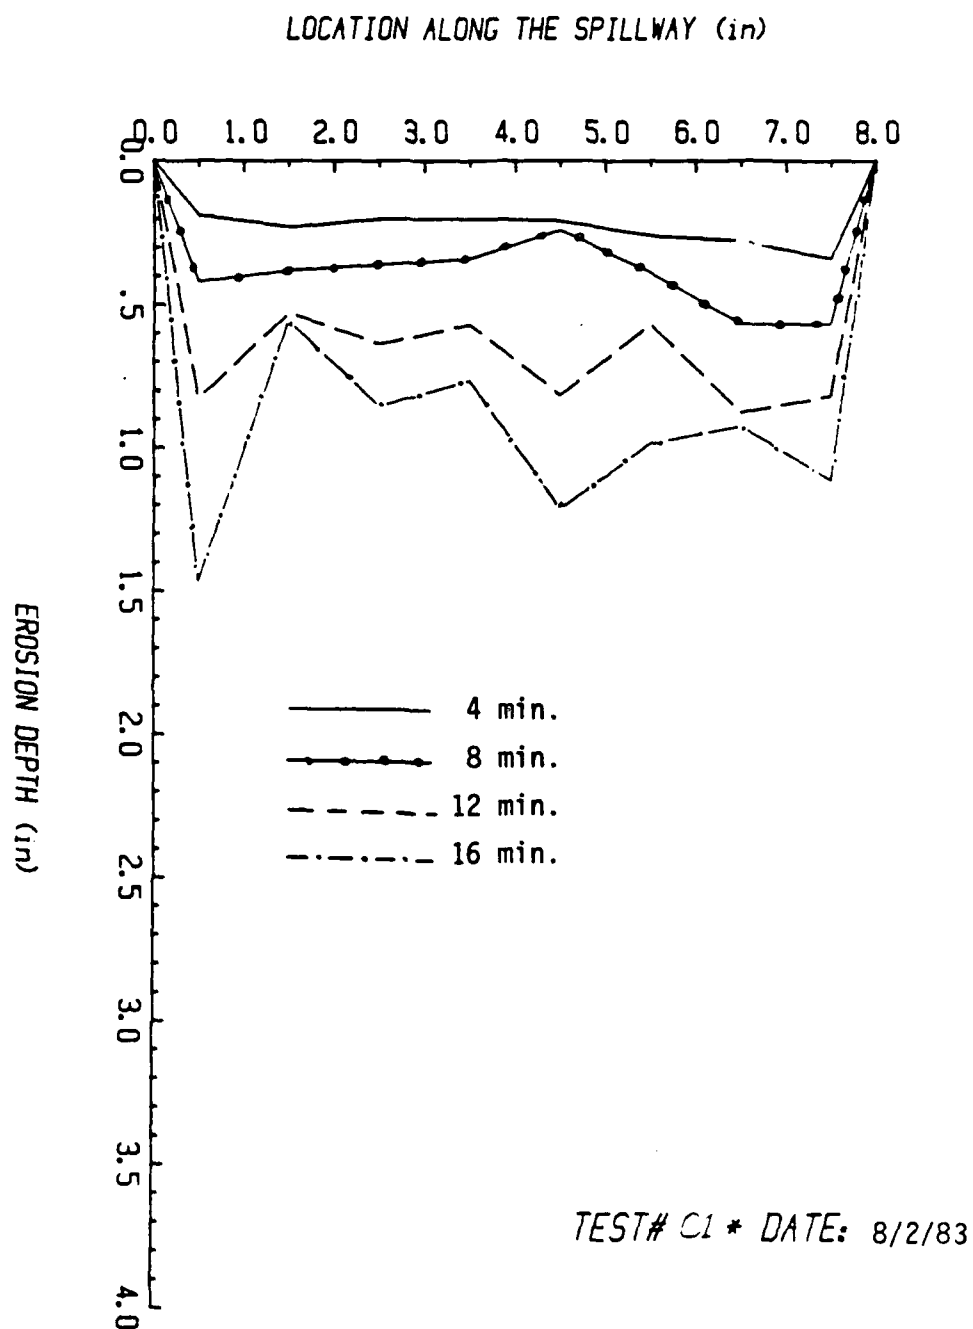
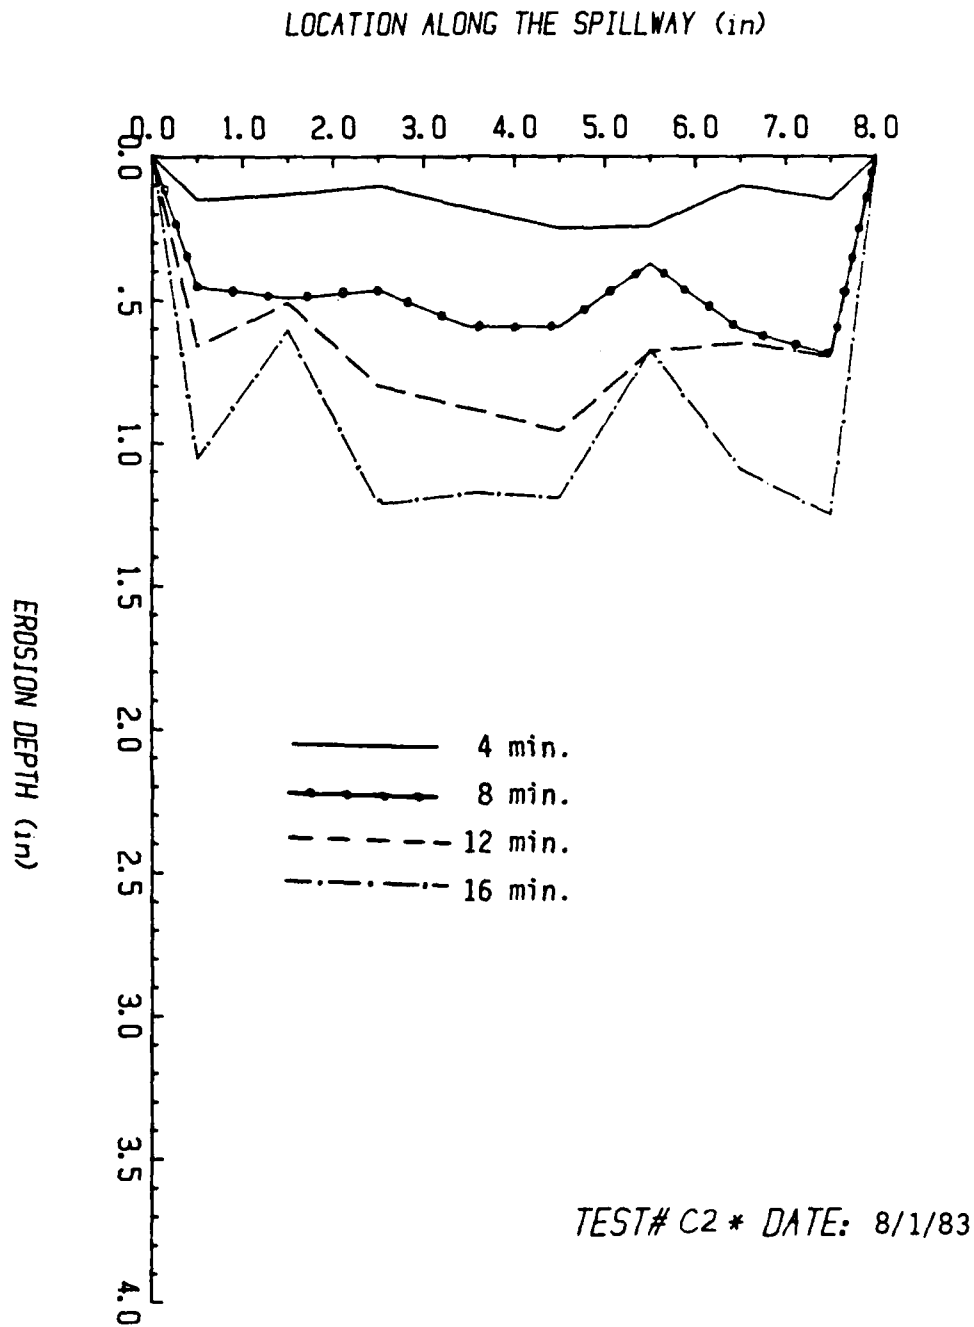
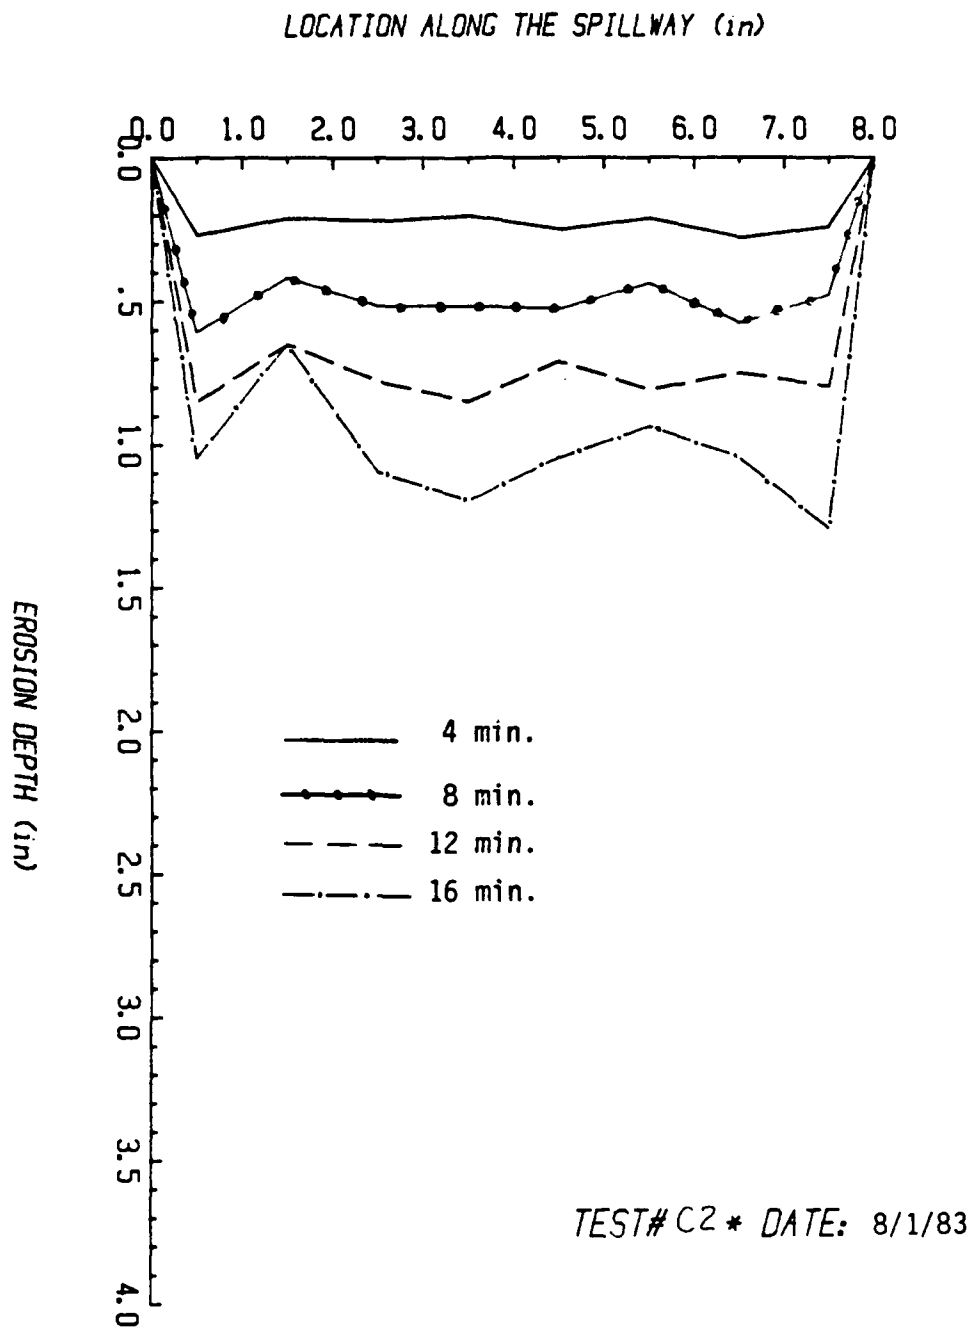
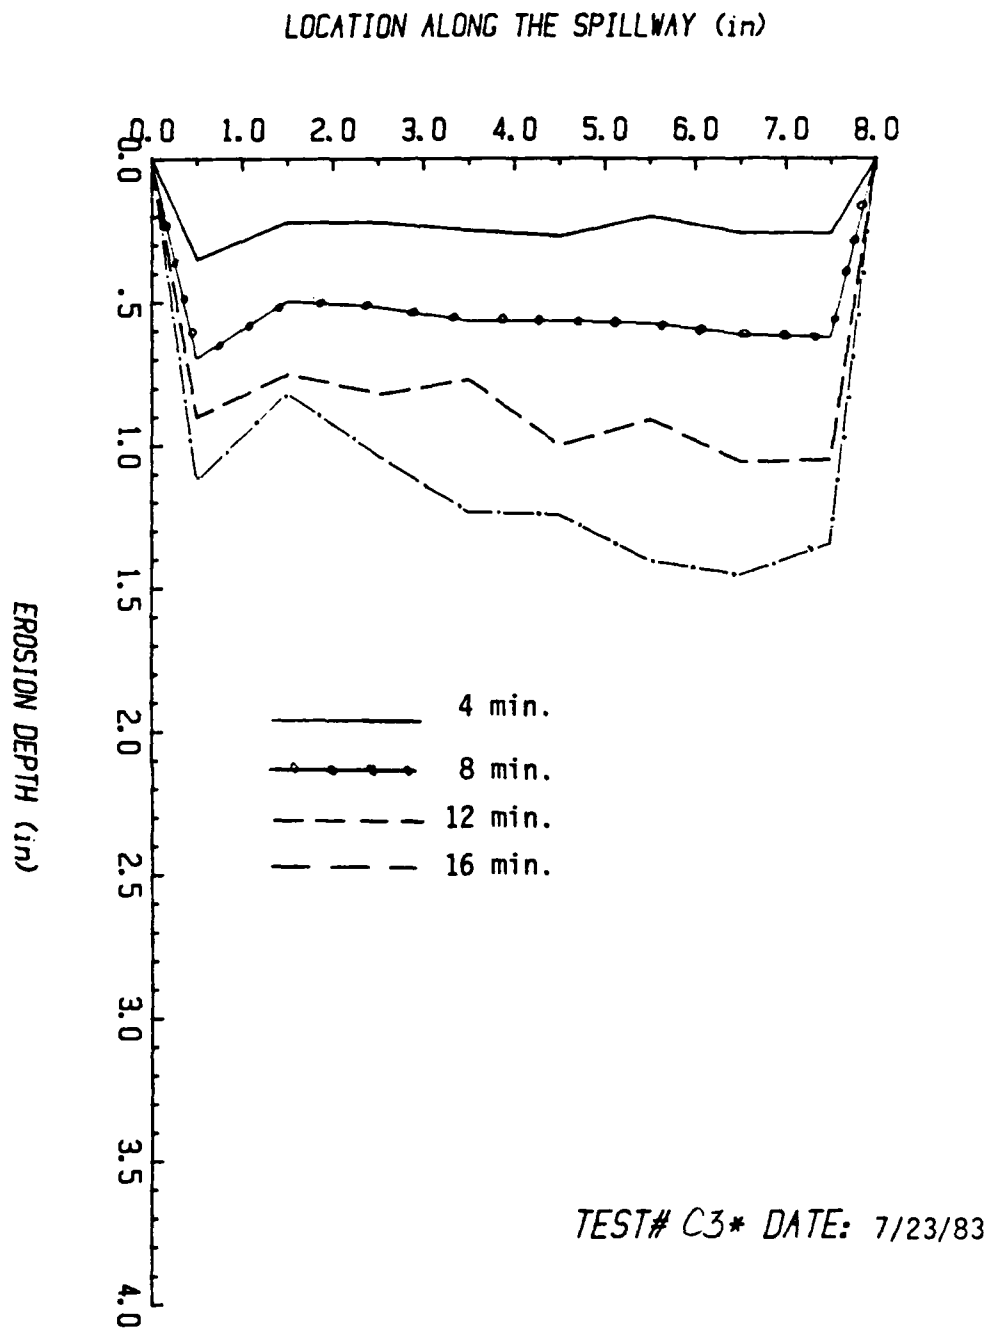
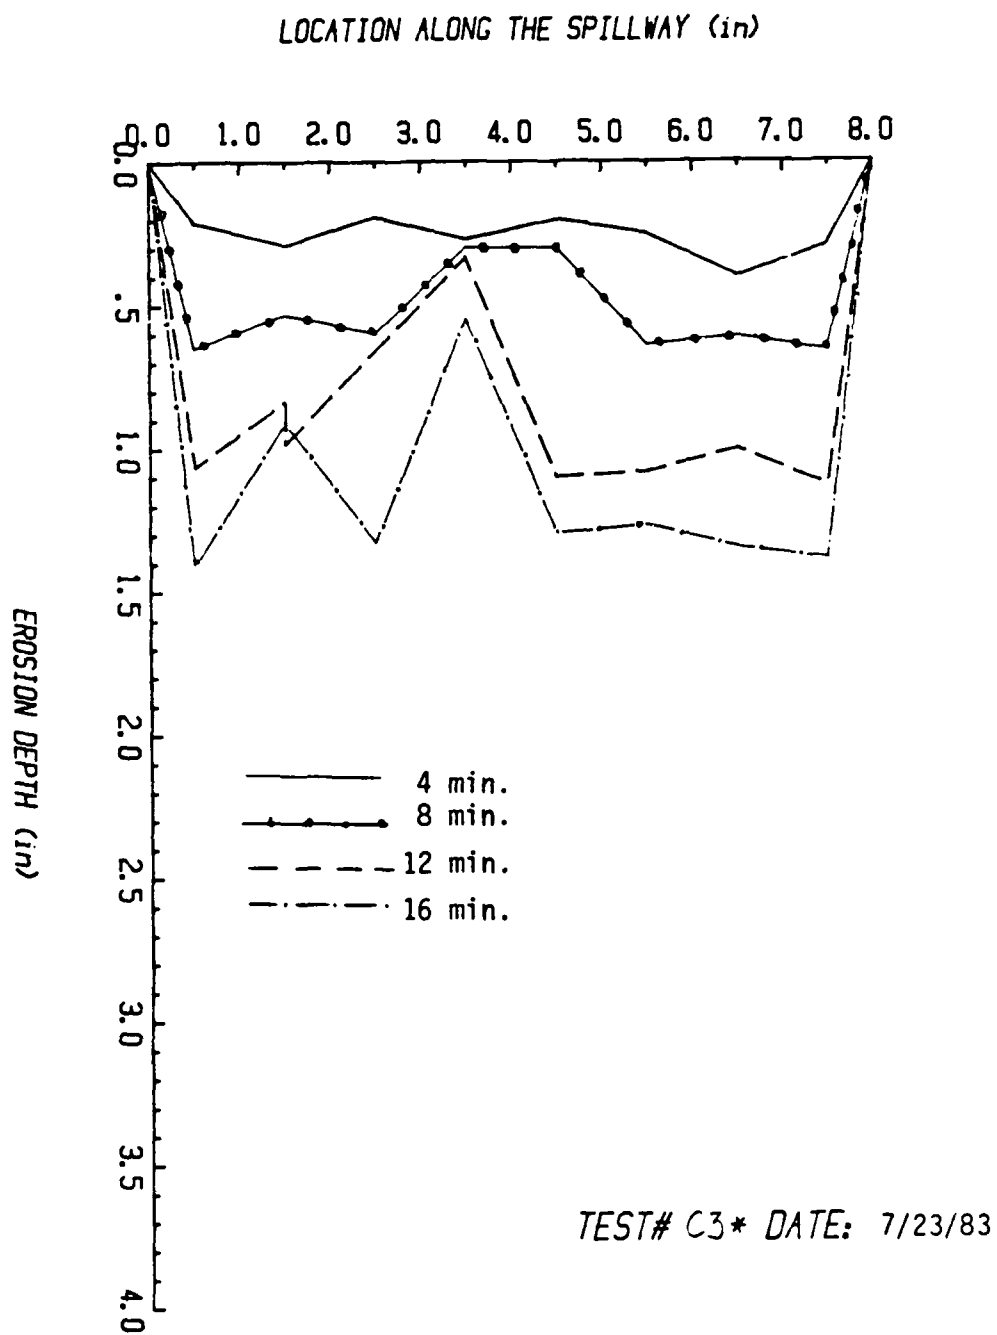
Fig.V.7 (a) Erosion profile cross sections of C-1 determined from manual measurements at row A

Fig. V.7 (b) Erosion profile cross sections of C-1 determined from manual measurements at row B

Fig. V.7 (c) Erosion profile cross sections of C-2 determined from manual measurements at row A

Fig.V.7 (d) Erosion profile cross sections of C-2 determined from manual measurements at row B

Fig. V.7 (e) Erosion profile cross sections of C-3 determined from manual measurements at row A

Fig. V.7 (f) Erosion profile cross sections of C-3 determined from manual measurements at row B

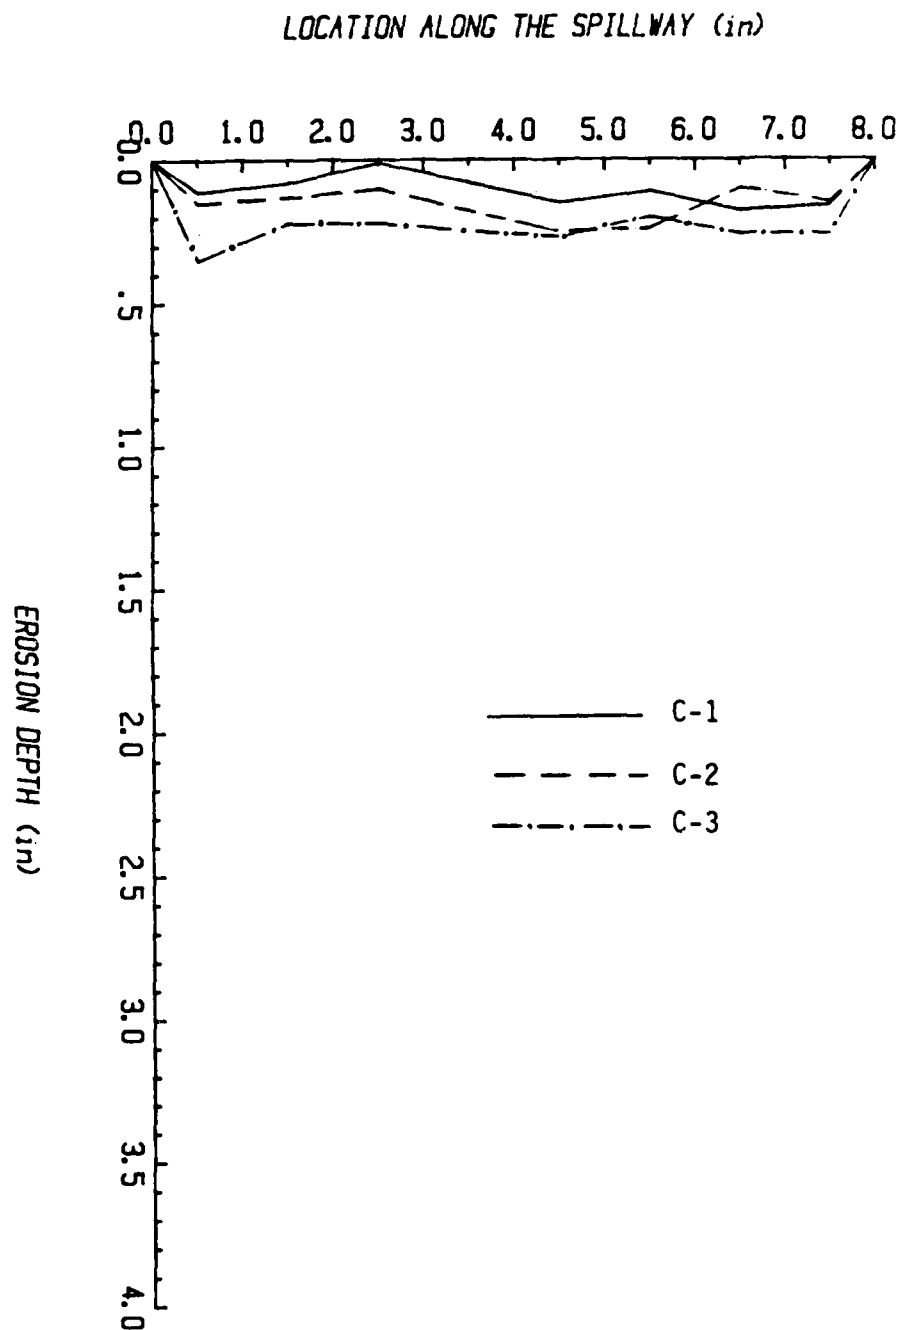
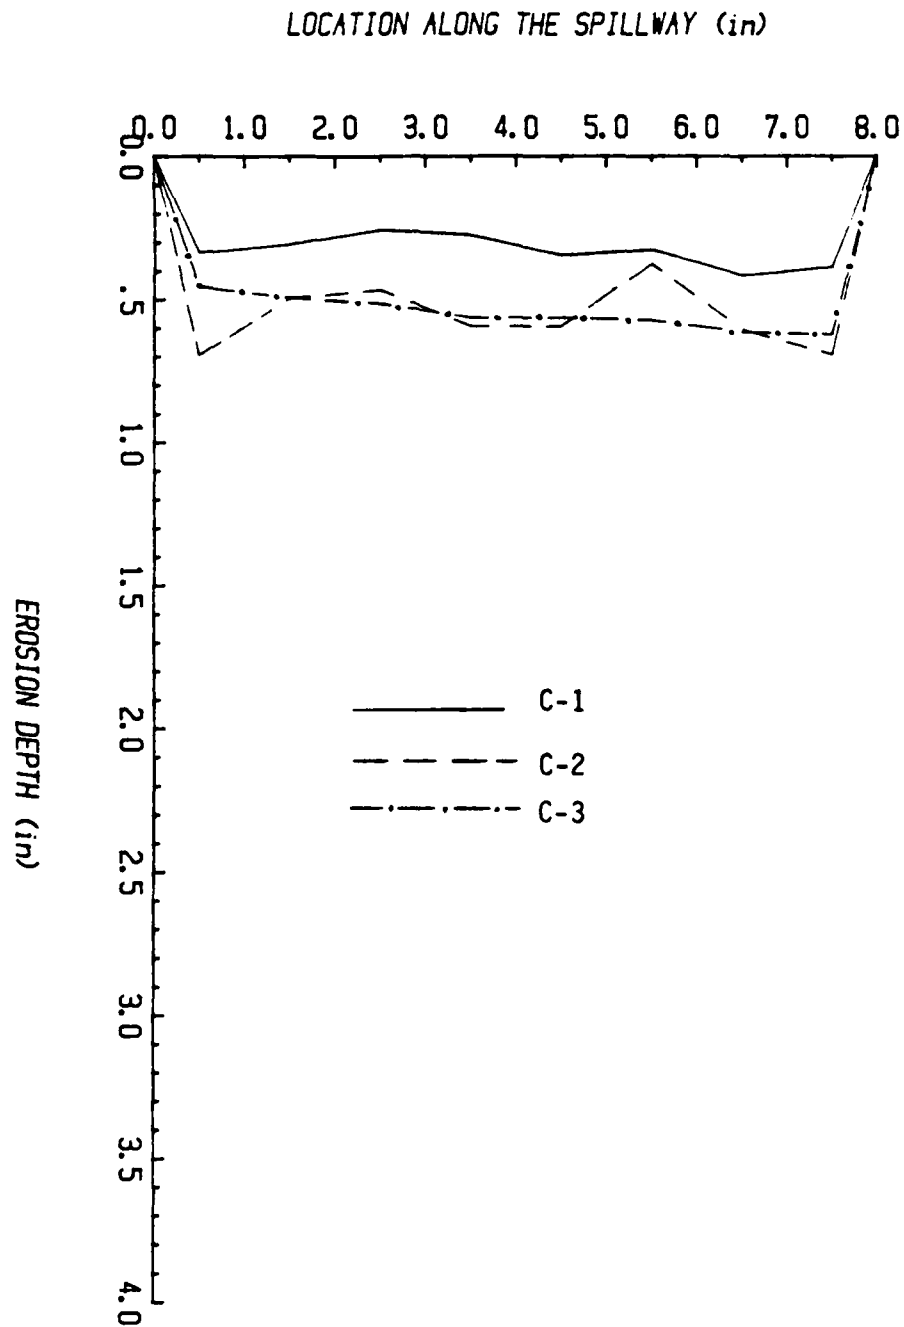
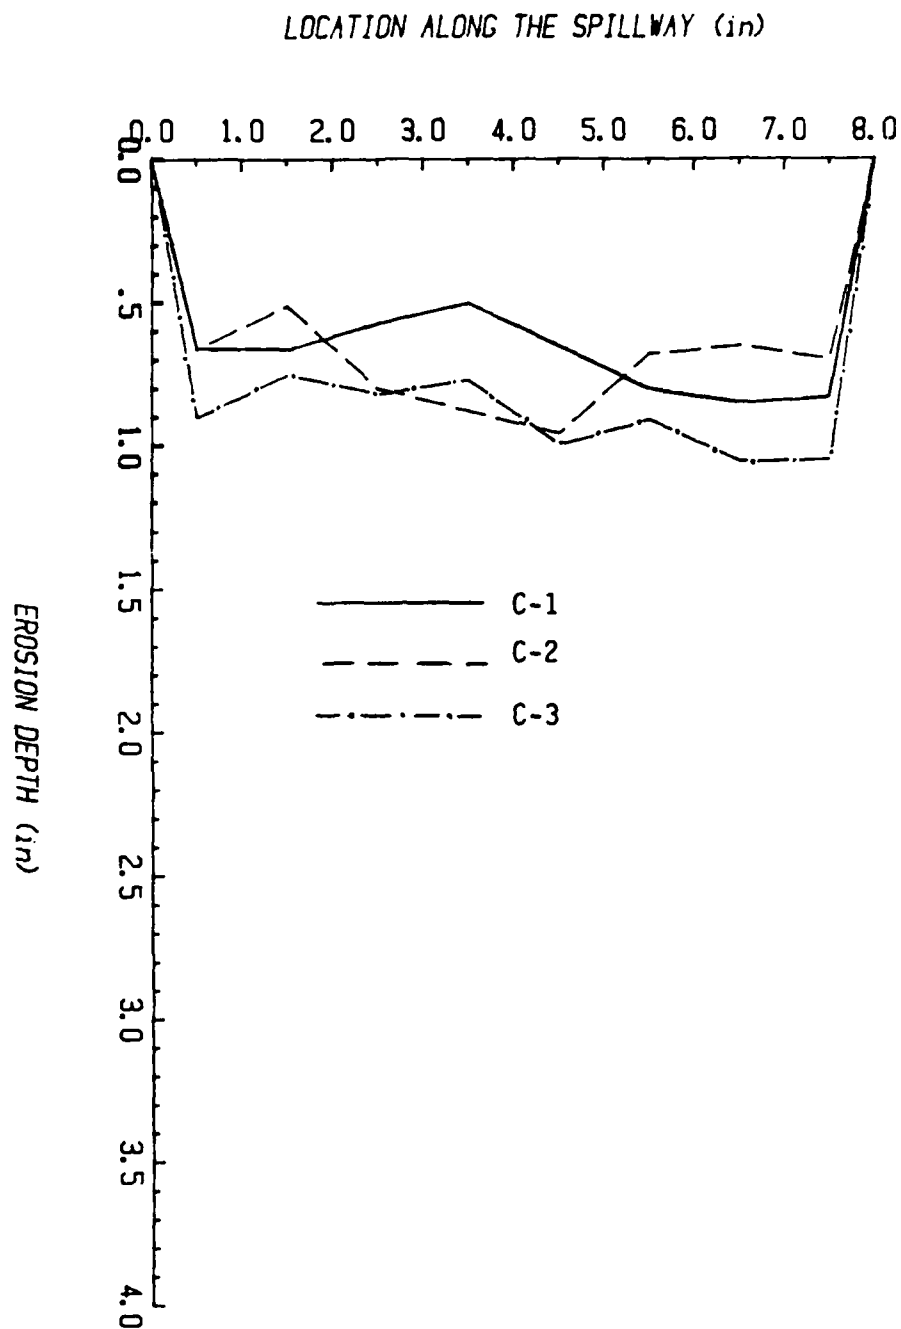
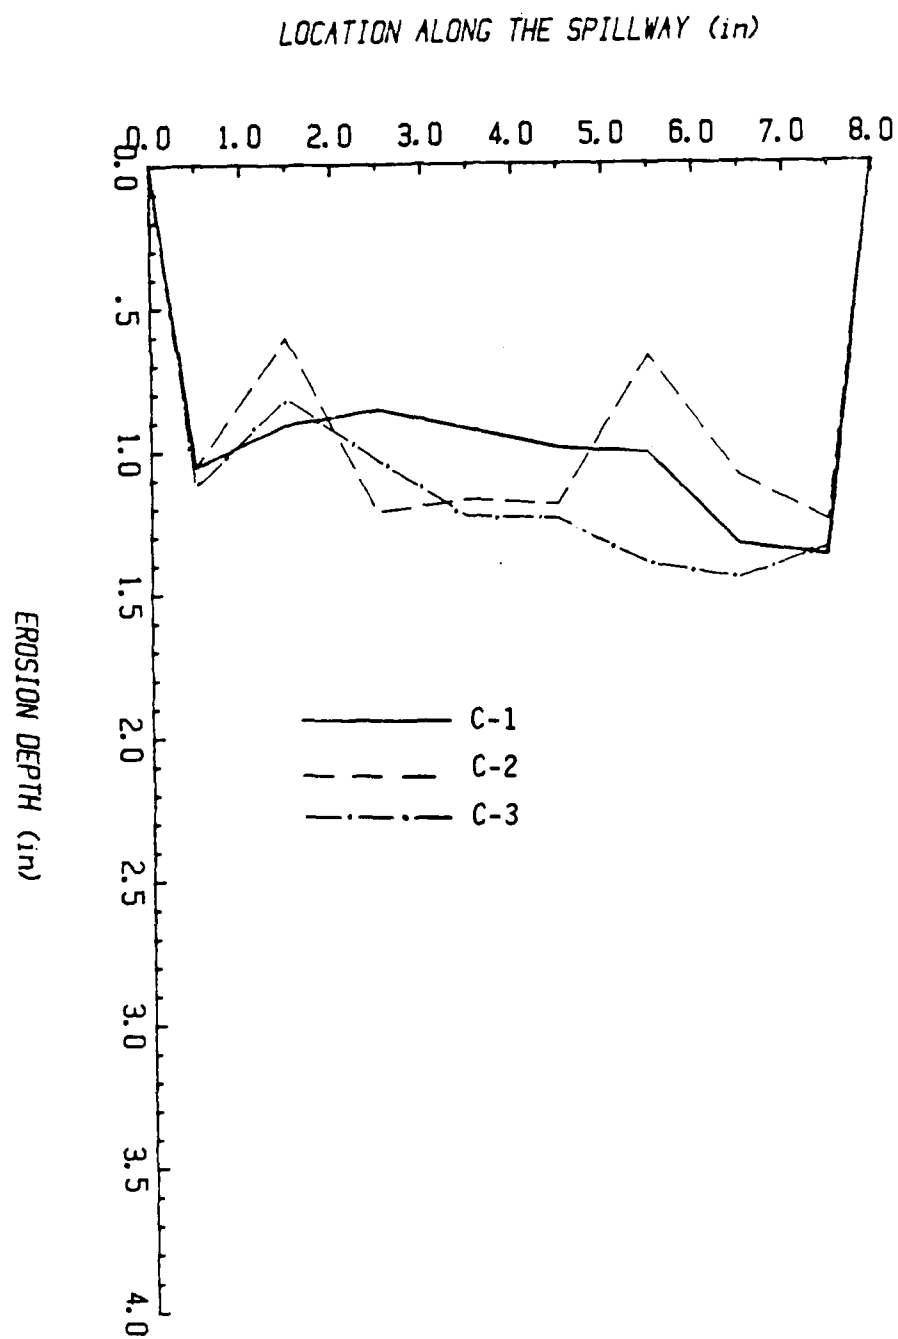
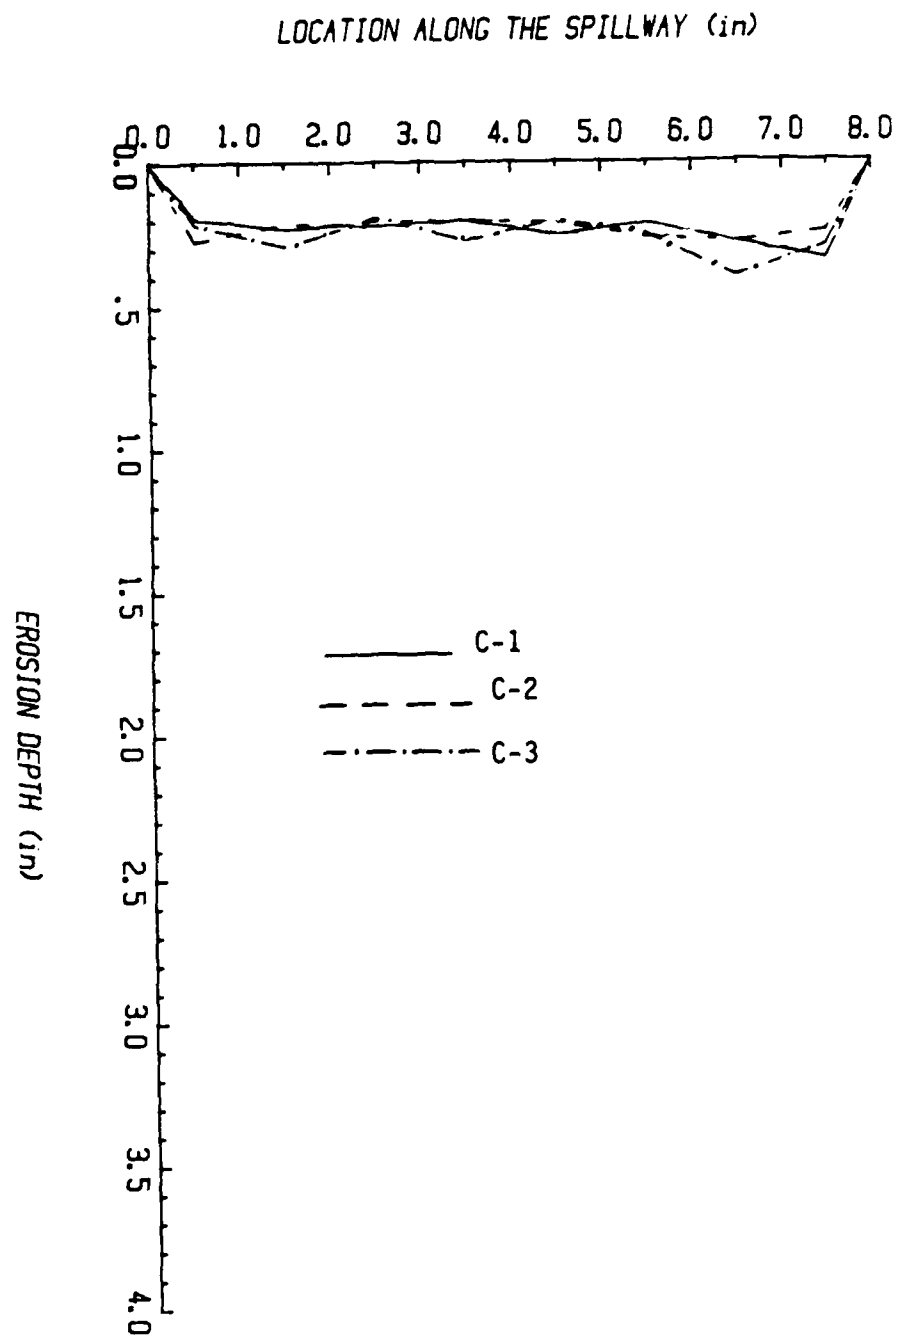
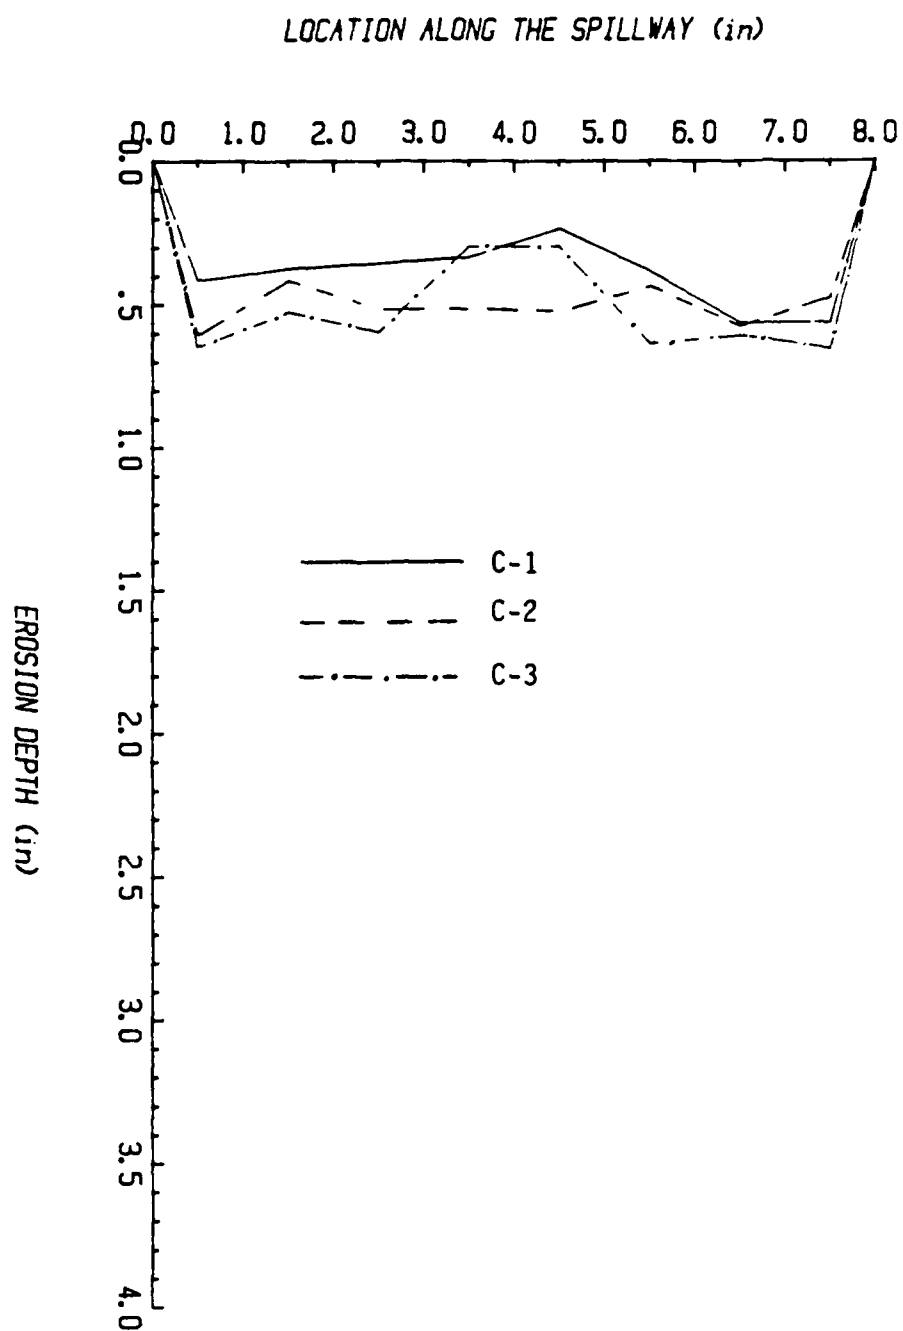
Fig.V.8 (a) Comparison of clay embankments erosion profile cross sections for row A after 4 min. of overtopping

Fig.V.8 (b) Comparison of clay embankments erosion profile cross sections for row A after 8 min. of overtopping

Fig. V.8 (c) Comparison of clay embankments erosion profile cross sections for row A after 12 min. of overtopping

Fig.V.8 (d) Comparison of clay embankments erosion profile cross sections for row A after 16 min. of overtopping

Fig. V.8 (e) Comparison of clay embankments erosion profile cross sections for row B after 4 min. of overtopping

Fig. V.8 (f) Comparison of clay embankments erosion profile cross sections for row B after 8 min. of overtopping

42. Based upon the observed erosion profile in the centrifuge tests, and comparison of erosion profiles presented in Figures V-8 and V-10, we conclude that tests on clay embankments are reproducible, and therefore the centrifuge is a feasible tool for modeling overtopping phenomena.

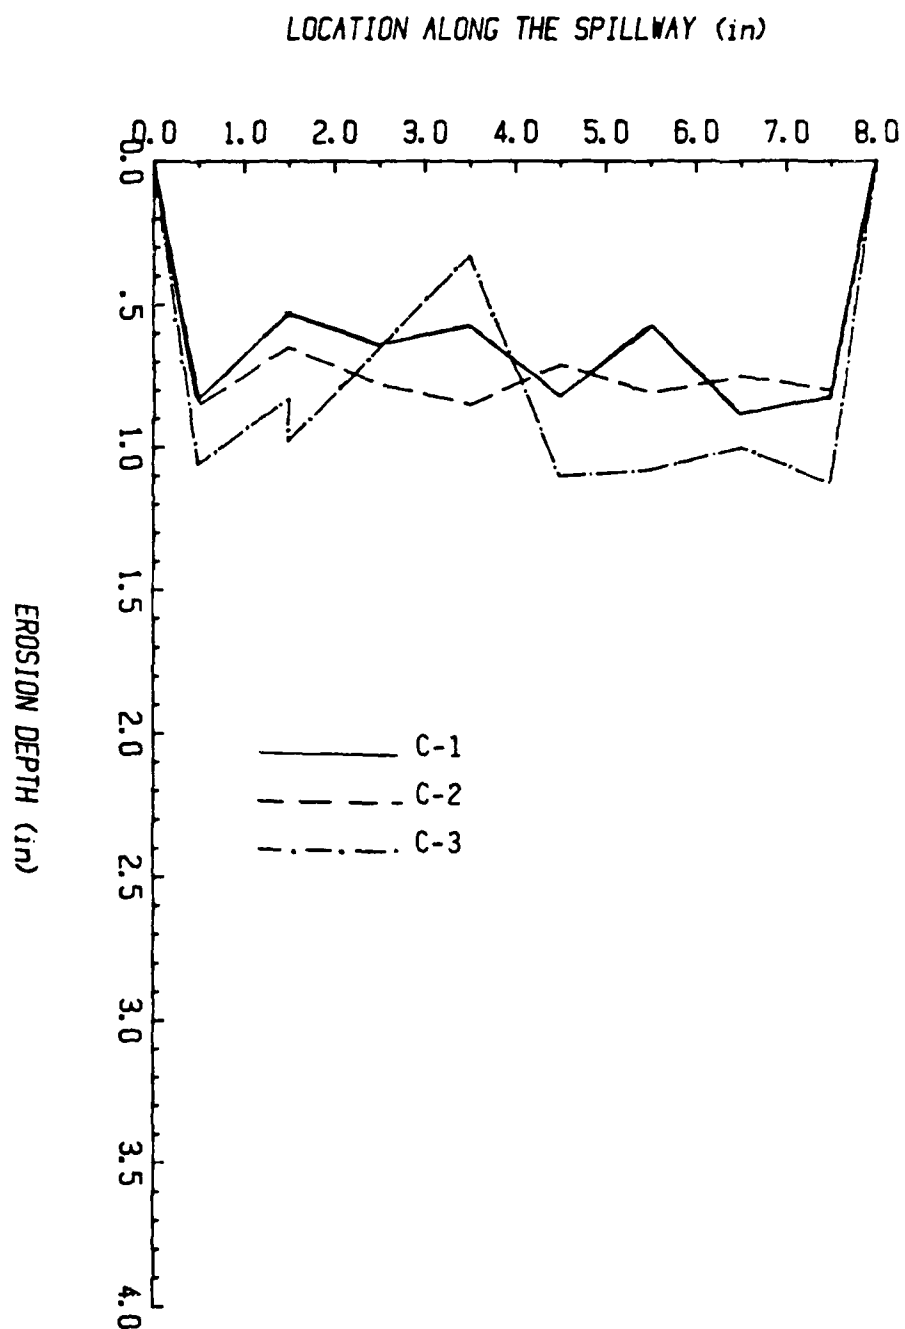
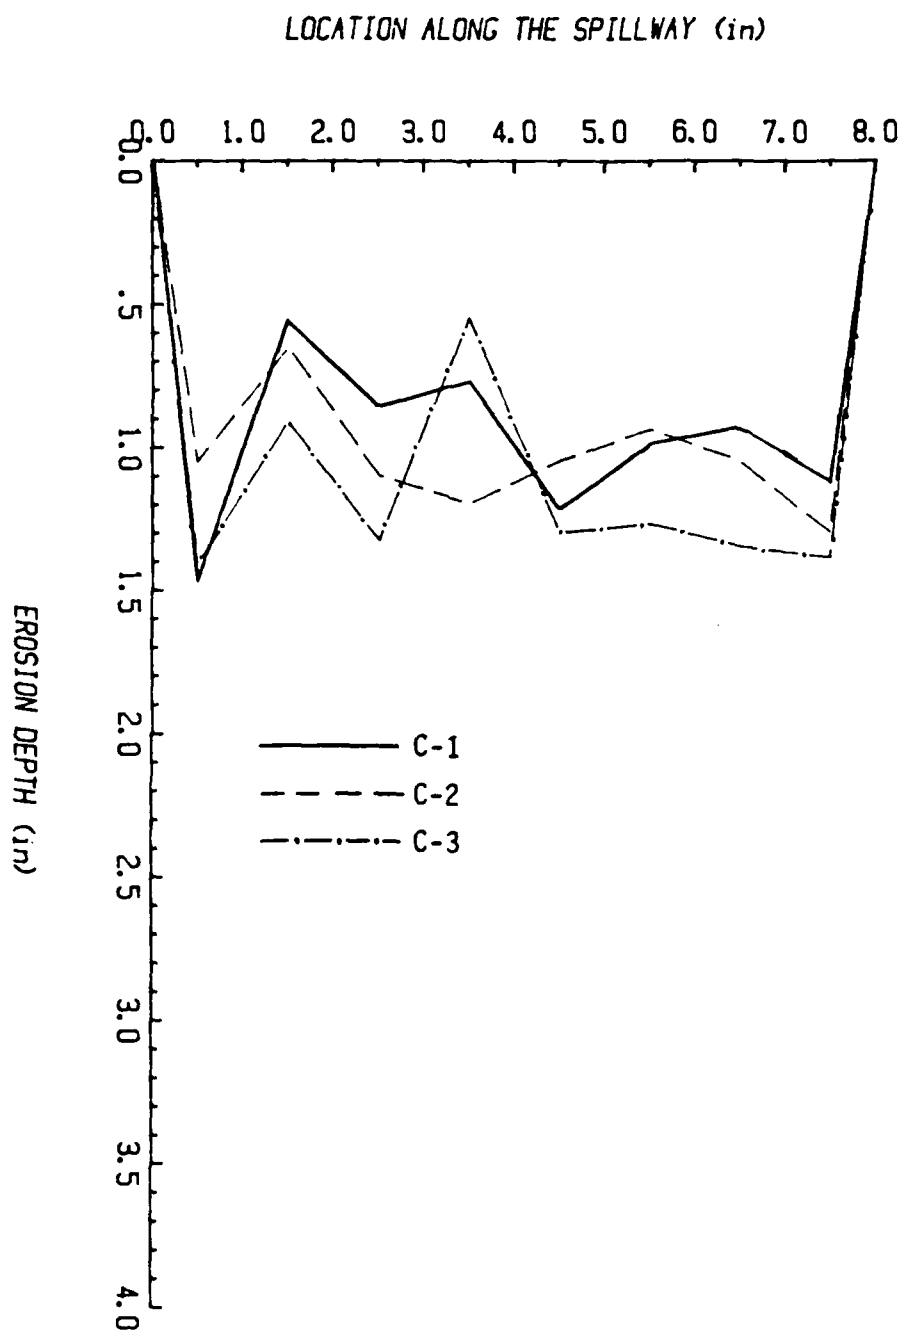
Fig.V.8 (g) Comparison of clay embankments erosion profile cross sections for row B after 12 min. of overtopping

Fig.V.8 (h) Comparison of clay embankments erosion profile cross sections for row B after 16 min. of overtopping

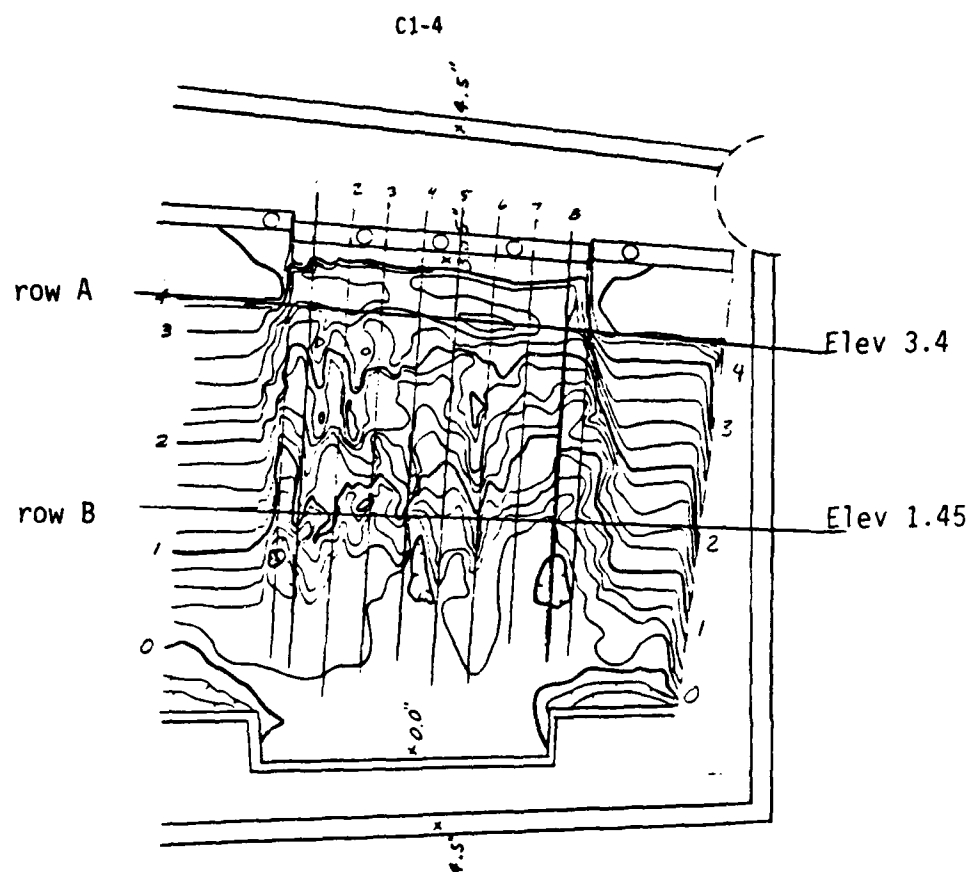
Fig. V.9 Contour map of clay embankment C-1 after 16 min. of overtopping

Contour interval = 0.2" , Scale = 1:4

and is shown in Figure V-9. Cross-sections A and B in test C-1, as measured by both the manual method and in the contour map, are shown in Figure V-10. As indicated by the figure the results of the two methods are in good agreement, thus confirming the accuracy of the erosion contours prepared from the stereo pair photographs.

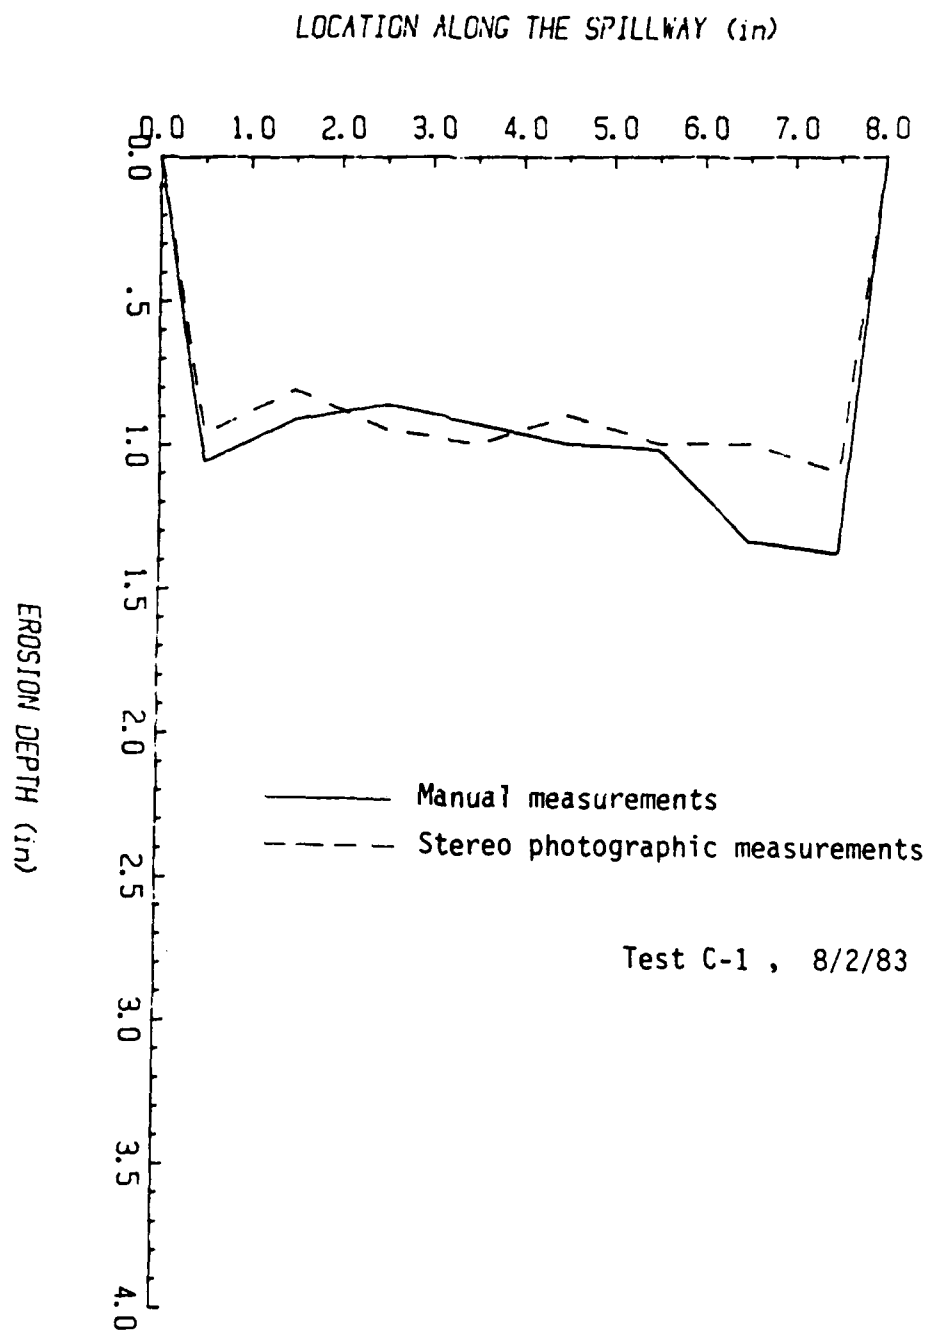
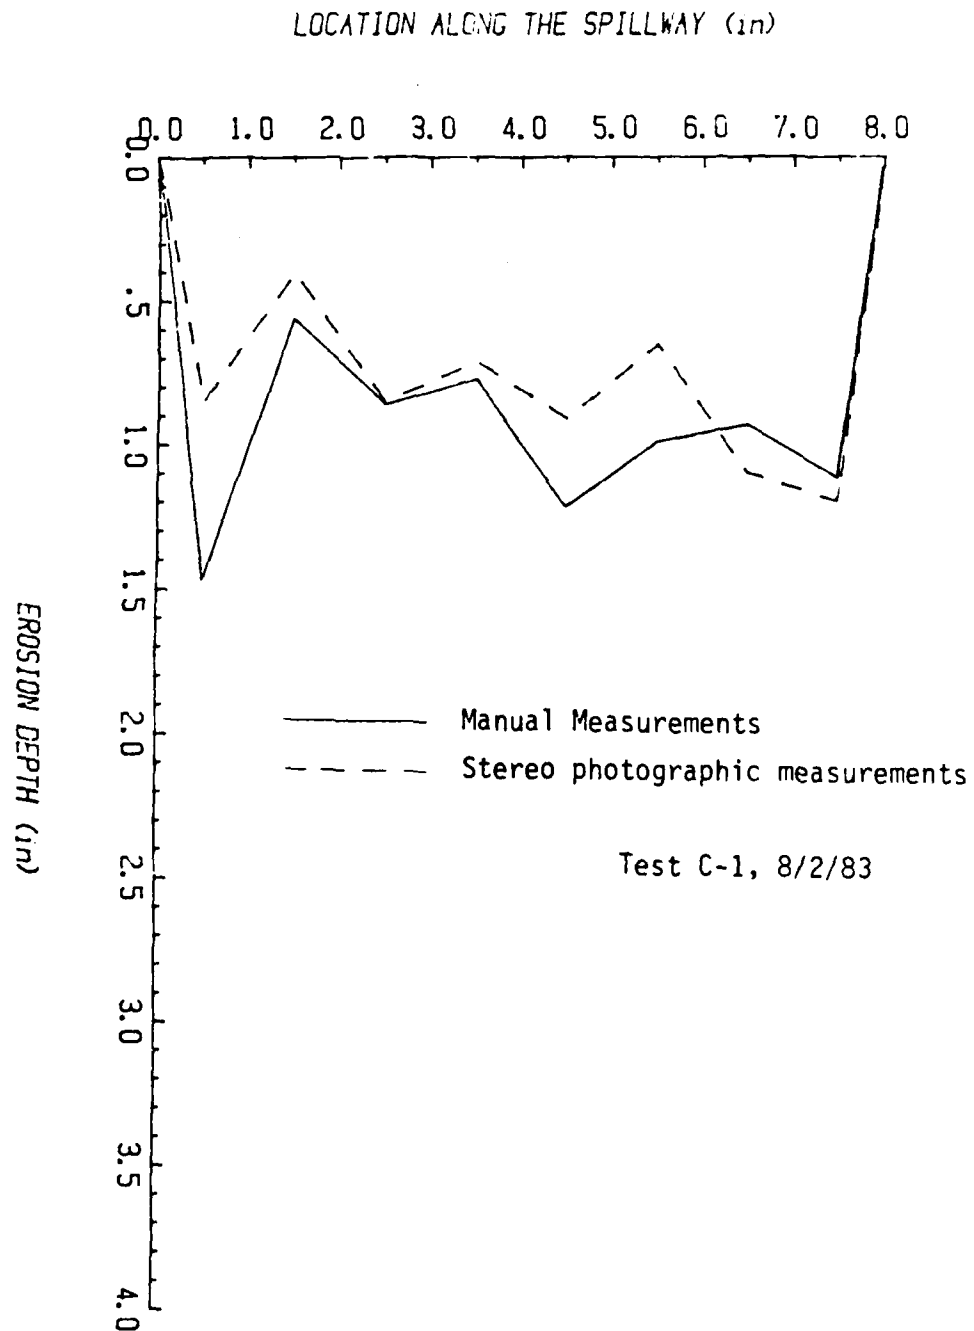
Fig. V.10 (a) Comparison of manual vs. stereo photographic measurements at row A in clay embankment C-1 after 16 min. of overtopping

Fig. V.10 (b) Comparison of manual vs. stereo photographic measurements at row B in clay embankment C-1 after 16 min. of overtopping
